*Highland Park*  
TEXAS

# HACKBERRY CREEK CORRIDOR

Conceptual Design & Development Report

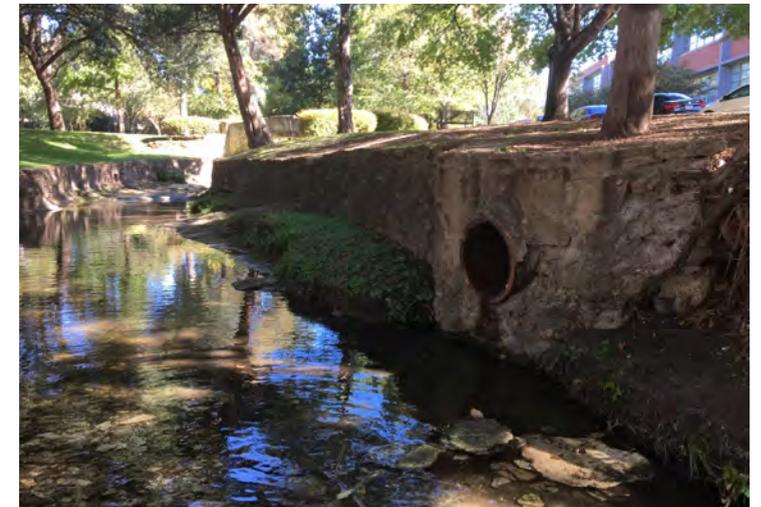
Exhibit 12 Before: Head wall and pipe flowing into creek channel located in Hackberry Creek Park North

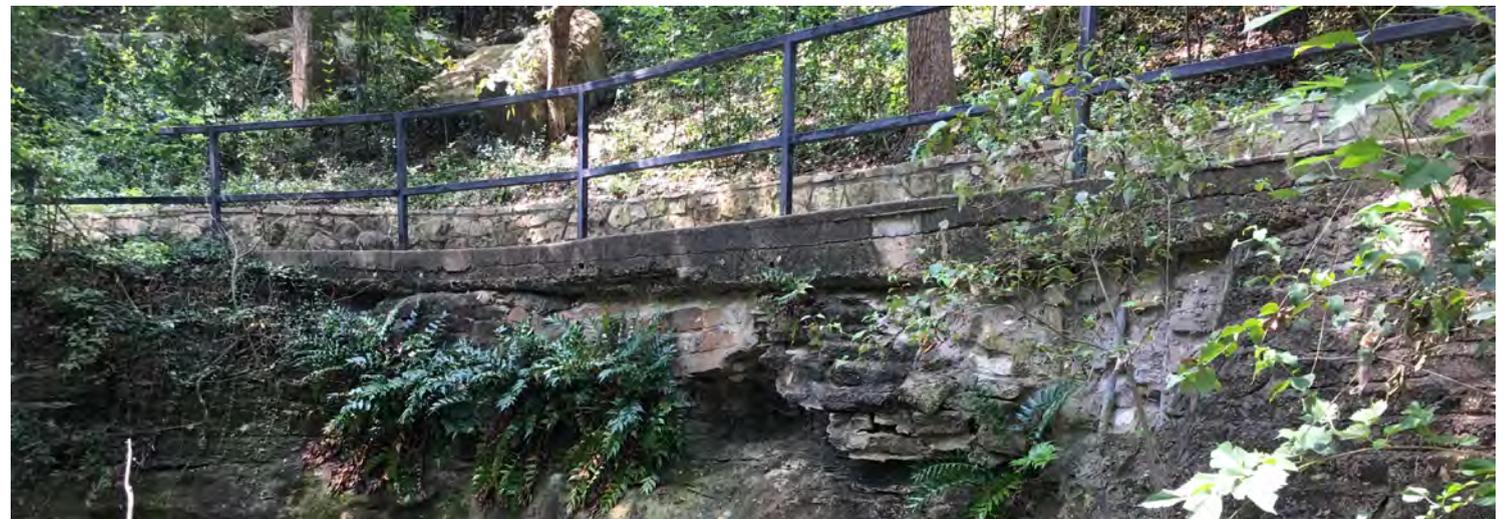
In exhibit 15 on page 14, the raised pedestrian walkway between Pedestrian Bridge #6 and Pedestrian Bridge #7 indicates erosion of the bedrock undermining the existing sidewalk. Picturesque holly fern has established a colony in the crevices creating a unique landscape encounter along the walkway. As a measure to preserve the historic (and scenic) alignment of the sidewalk, the rendering

Exhibit 15 Before: Walkway in Davis Park

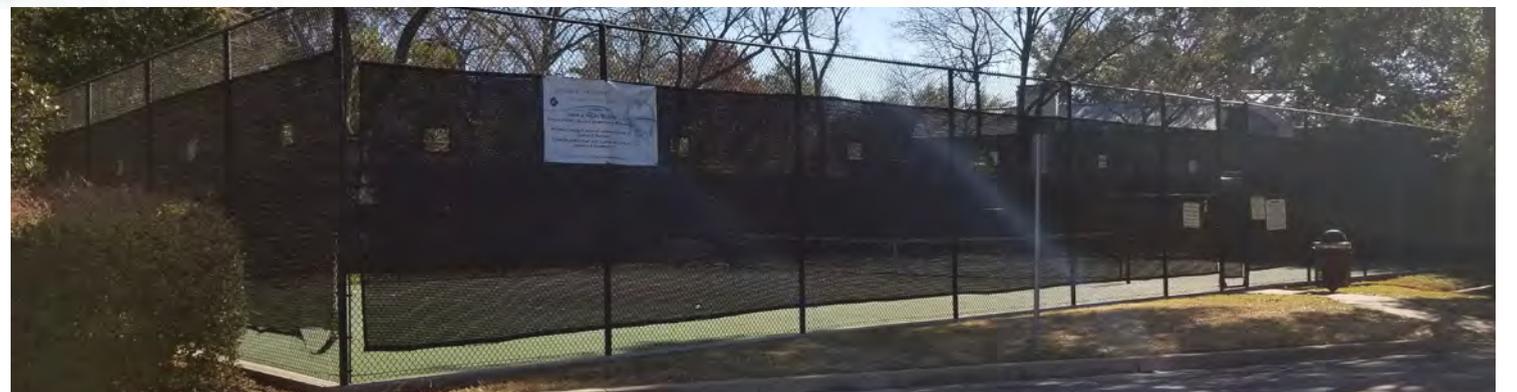
Exhibit 20 Before: Existing conditions of Tennis Court #2

The perspective sketch in Exhibit 19 on page 18 delineates a design concept intended to gentrify the appearance of the court. The enhancements would remove the chain link fence and windscreen, and replace them with steel lattice and masonry. Windscreen may be incorporated on the court side of the lattice. The height of the fence's middle section would be lowered, giving the court an inviting gardenesque appearance that blends with the architectural form of the corridor. The lowered fence enables public safety patrols to maintain a vigil when the court is not in use. Supplemental landscape around the perimeter of the court would suggest a more harmonious relationship with the surrounding natural landscape. Though this illustration is for Tennis Court #2, the proposed improvements are suitable for Tennis Courts #1 and #7 as well.

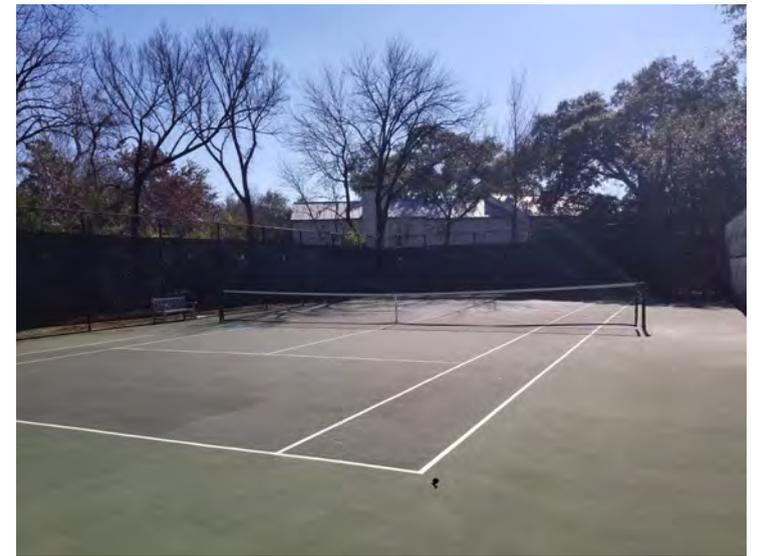
Exhibit 73: Tennis Court #2

Located near the northern most point of Hackberry Creek, this tennis court is in good condition. Resurfacing of the tennis court is scheduled in Fiscal Year 2018 - 2019. The existing sidewalk access is slightly deteriorated, and the court's drinking fountain is not immediately accessible.

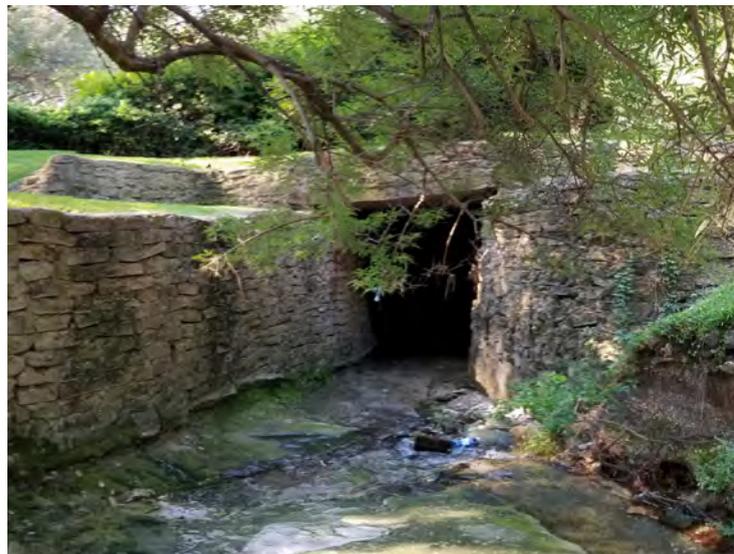
Exhibit 76: Beverly Drive

through the area consists of limestone. The deck and superstructure exhibit some minor problems including localized areas of missing or loose mortar, but are generally in good condition. The substructure shows minor deterioration and is in satisfactory condition. The bridge opening is partially obstructed by fill. A future study could be conducted to analyze the hydraulic benefit of increasing the open area underneath the bridge.

The hydraulic study for Hackberry Creek shows that Beverly Drive is overtopped by a 10-year storm. This 10-year storm results in approximately 0.5 feet of water. A 100-year storm results in an overtopping depth of over one foot. Considerations should be made for improving the hydraulic opening.

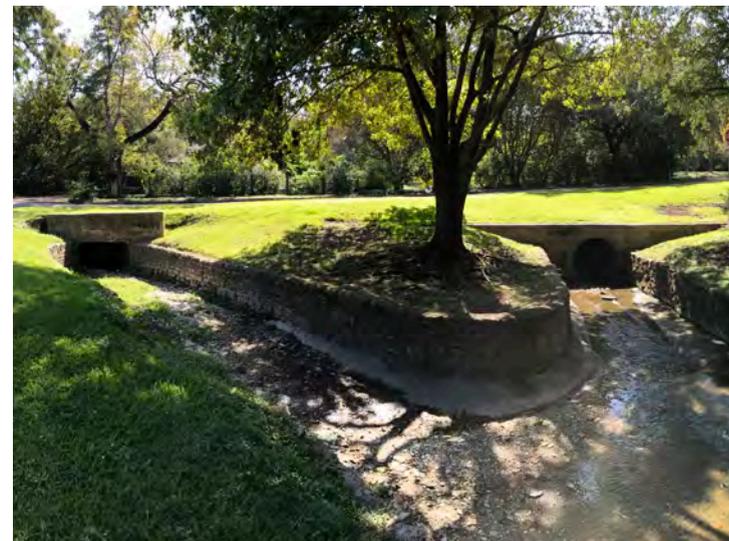
Exhibit 77: Miramar Avenue

The hydraulic study for Hackberry Creek shows that Miramar Avenue is overtopped by a 10-year storm, which results in an overtopping depth of nearly two feet, while a 100-year storm would result in a depth of nearly three feet. Considerations should be made for improving the hydraulic opening.

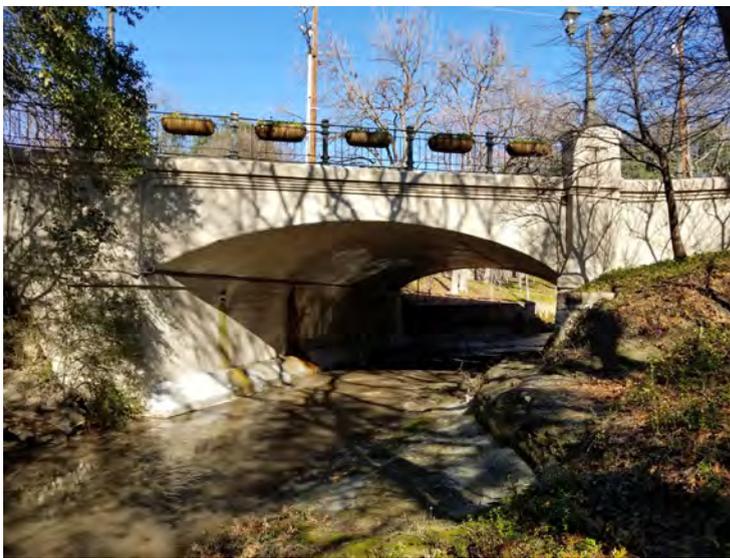
Exhibit 78: Euclid Avenue

This single span concrete arch bridge carries two lanes of traffic and sidewalks over Hackberry Creek. It is found near the Highland Park Town Hall and the northern end of Prather Park. The bridge superstructure, substructure, and deck are in satisfactory condition, and appear to have been recently refaced, which could obscure underlying issues. The hydraulic study for Hackberry Creek shows that Euclid Avenue carries 100-year flows without overtopping.

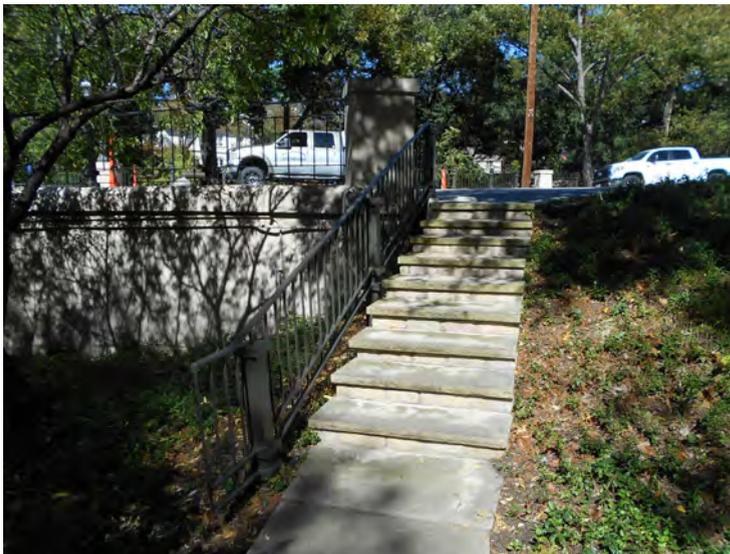
Exhibit 79: Stairway #1

does not comply with current codes for accessibility or safety standards. The stairway appears structurally sound and constructed of concrete with stone veneer. A drain pipe on the west side is unsightly and should be concealed. Overall, the steps are attractive and the stone veneer is in good repair. The railing is attractive and in good condition, though it does not meet current codes. The recommendation for this stairway is to maintained in its current condition, though options for future updates to current codes should be considered.

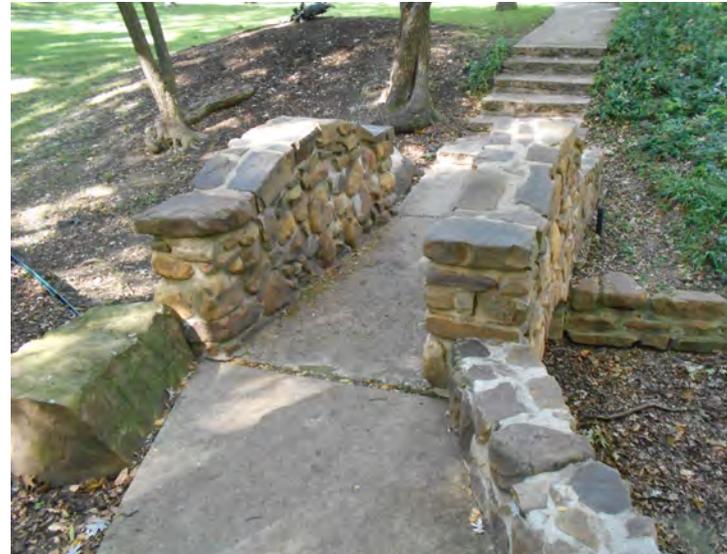
Exhibit 80: Pedestrian Bridge #2

This pedestrian bridge is found in Prather Park and crosses over a drainage swale. It is a single span concrete arch bridge with stone facing. The mortar of the bridge facing exhibits cracking. Several stones have minor cracking. The face has areas of efflorescence. The underside of the bridge has honeycombing with exposed aggregate. Multiple voids were observed between the arch and stone facing.

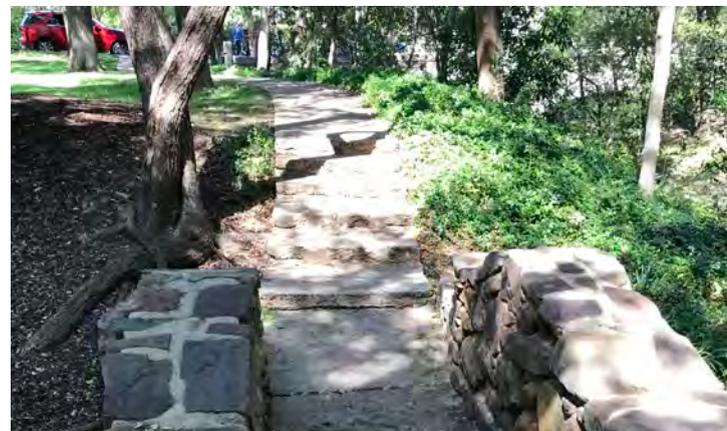
Exhibit 81: Stairway #2

Stairway #2 is located south of Euclid Avenue and leads to Pedestrian Bridge #2 in Prather Park. It has no handrail. It is narrower than four feet wide; therefore, current building codes would not require a handrail. The adjoining pathway would not be considered as an accessible route. The steps appear to be of stone masonry construction with some cracking and deterioration of the mortar. Aesthetically, the steps match the brownstone of Pedestrian Bridge #2, but differ from the other hardscape elements in the corridor which are predominantly limestone. The near term recommendation is to maintain the repoint of the mortar joints; however, options for future updates to current codes should be considered.

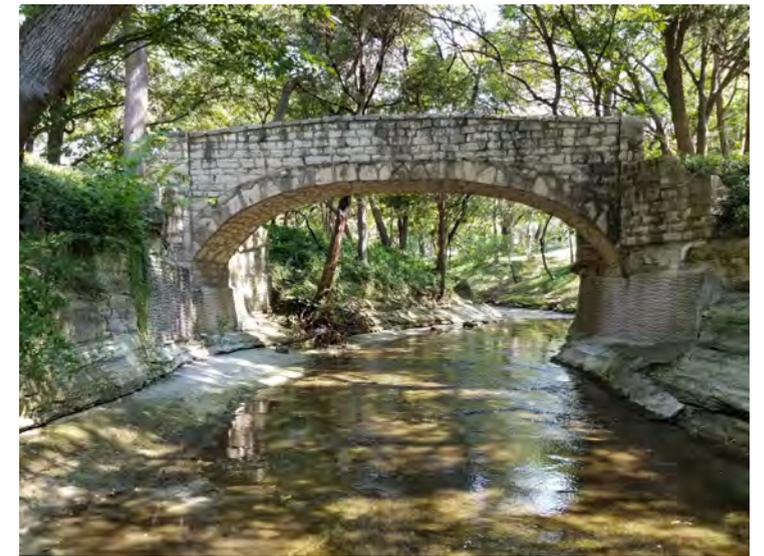
Exhibit 82: Pedestrian Bridge #3

This masonry arch bridge in Prather Park crosses over Hackberry Creek. The superstructure and substructure are in fair condition. The structure has areas of missing and cracked stones in need of repair. Previous concrete repairs were made to the abutments, where the concrete was textured to mimic the appearance of limestone to match its surroundings, whose banks consist of natural limestone.

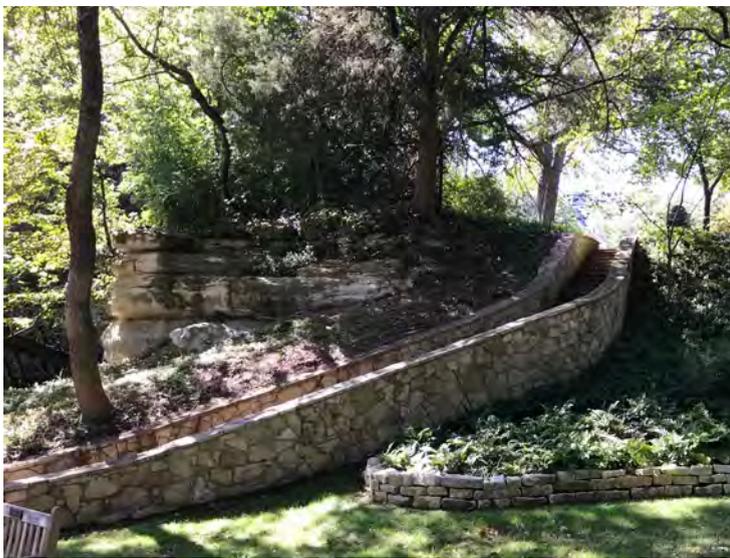
Exhibit 83: Stairway #3

This long, graceful stairway is located at the northwest side of Hackberry Creek, adjacent to Pedestrian Bridge #3. It is flanked on either side by low limestone cheek walls varying in height from 12”-24” above the treads. These walls would not suffice for current codes for accessibility or safety standards. The stairway appears structurally sound with treads and risers constructed of concrete. Overall, the steps are attractive, and the stone veneer is in generally good repair, though some cracking is evident. This stairway should be maintained and preserved in its current condition. If the stairway is altered, it will likely require a compliant guardrail due to adjacent topography.

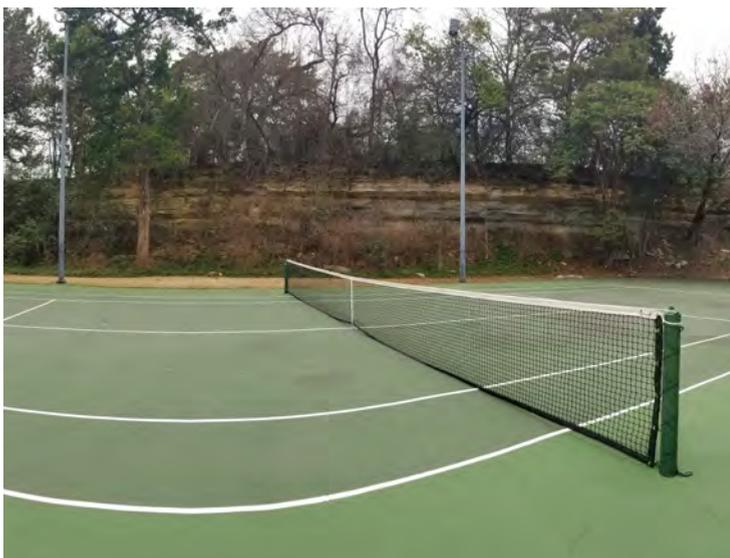
Exhibit 84: Tennis Court #1

Tennis Court #1 is located near Lexington Avenue. The court’s surface shows major deterioration. Other areas of concern include the fencing, windscreens, backboard, seating, lighting, and the accessibility of the area. It is recommended that the court be reconstructed elsewhere. Renovations to the tennis court are identified in the Town’s Capital Improvement Plan.

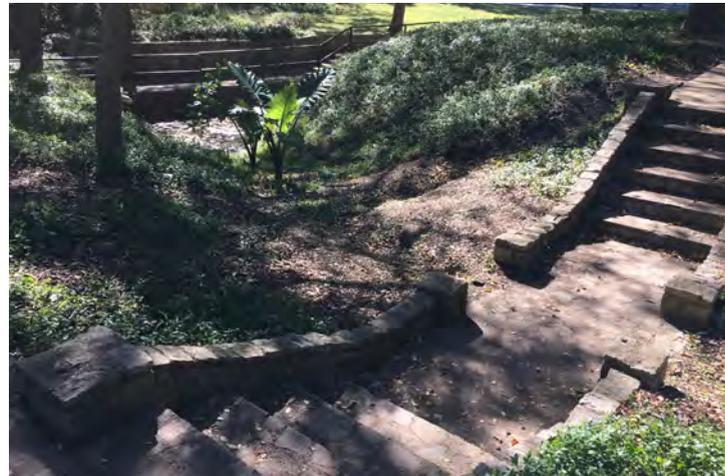
Exhibit 85: Stairway #4

This stairway is comprised of two short staircases coming together as a low water crossing. Constructed of limestone, it is flanked on either side by low limestone cheek walls 12” above the treads, terminating in short stone columns. Overall, the steps are attractive; the stone and mortar are in generally good repair, though some minor cracking is evident. This stairway should be maintained and preserved in its current condition.

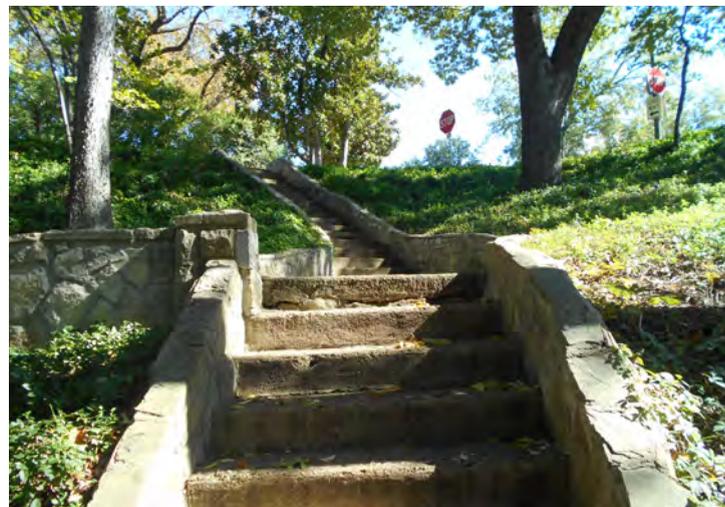
Exhibit 86: Stairway #5

Located at the southeast corner of Prather Park, this stairway leads down from the street level to either side of the creek, crossing paths above the Lexington Avenue culvert. It is flanked on either side by low limestone cheek walls varying in height from 12”-18” above the treads. The stairways appear structurally sound with treads and risers constructed of concrete, though some cracking is evident due to settling over time. These stairs are a landmark in the park, attractive, and in generally fair condition as treads vary. This stairway should be maintained and preserved in its current condition. If the stairway is repaired in the future, alterations should be as minimal as possible, in an effort to avoid the compulsory addition of modern handrails.

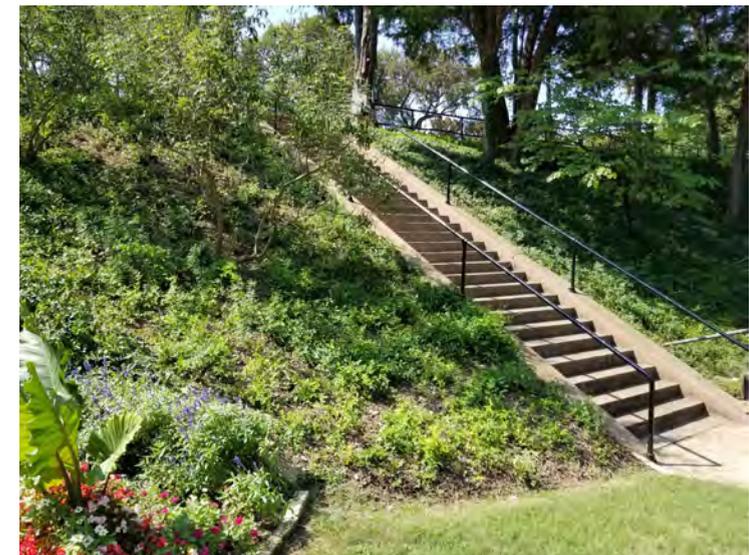
Exhibit 87: Stairway #6

Located on the south edge of Prather Park adjacent to Lexington Avenue, this stairway is constructed of concrete and is in excellent repair. Constructed of concrete, it has an elegant simplicity, though it does not match the stone masonry appearance of other nearby staircases. The handrail height does not comply with current code, nor do the openings between the mounting posts. The short-term recommendation is to leave this stairway as-is, pending the design and construction of the proposed Lexington Avenue Esplanade.

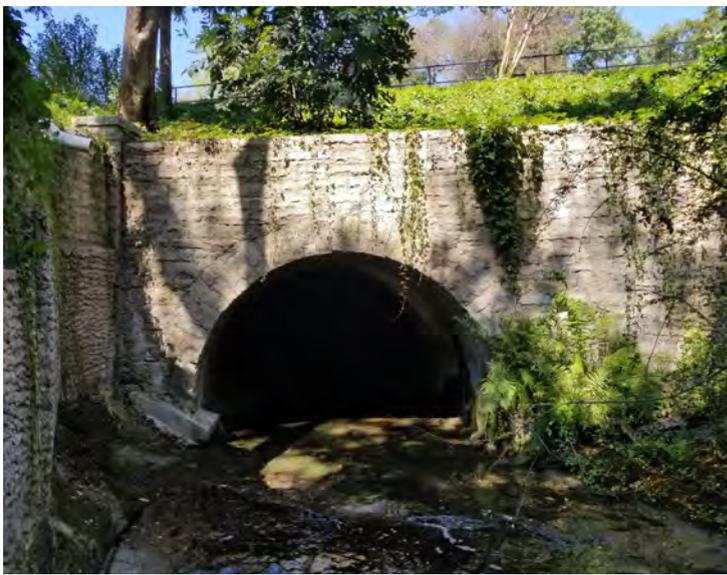
Exhibit 88: Lexington Avenue

The Lexington Underpass provides passage beneath Lexington Avenue to pedestrians using the Hackberry Creek Corridor. During high flow events, it acts as a relief culvert. The structure is in excellent condition with no noticeable or noteworthy deficiencies.

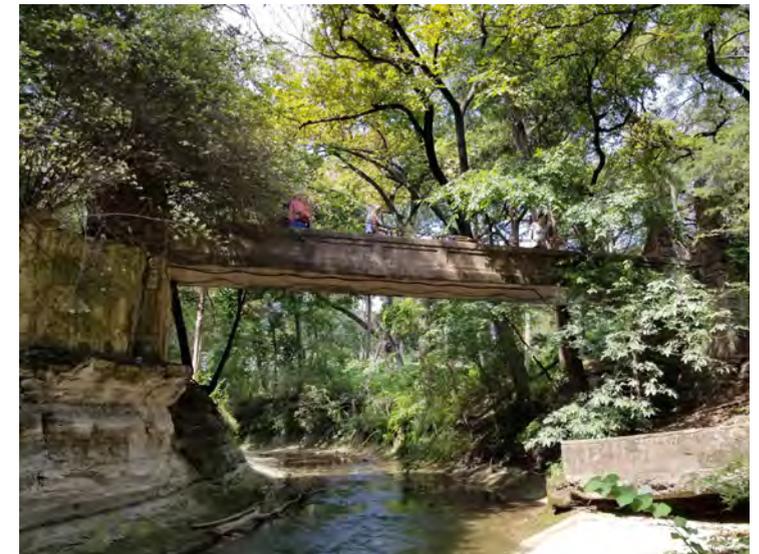
Exhibit 91: Pedestrian Bridge #5

the bridge from the pillars acts as a makeshift rail and mimics the appearance of a suspension bridge. The superstructure and substructure are in satisfactory condition.

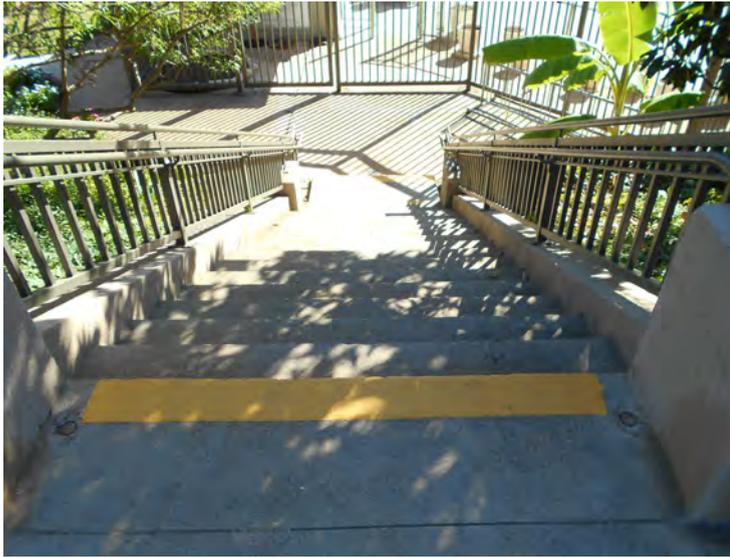
Exhibit 92: Stairway #8

Located opposite Stairway #6 on the northern edge of Davis Park, this stairway is similar in vintage, style, and construction to Stairway #6. Leading down to the entrance gate at the Town Swimming Pool, the handrail resembles that of stairway #7, but does not have the required extensions at the top and bottom of the stairway. Constructed of concrete, it does not match the stone masonry appearance of other nearby staircases. The near-term recommendation is to leave this stairway as-is, pending the design and construction of the proposed Lexington Avenue Esplanade.

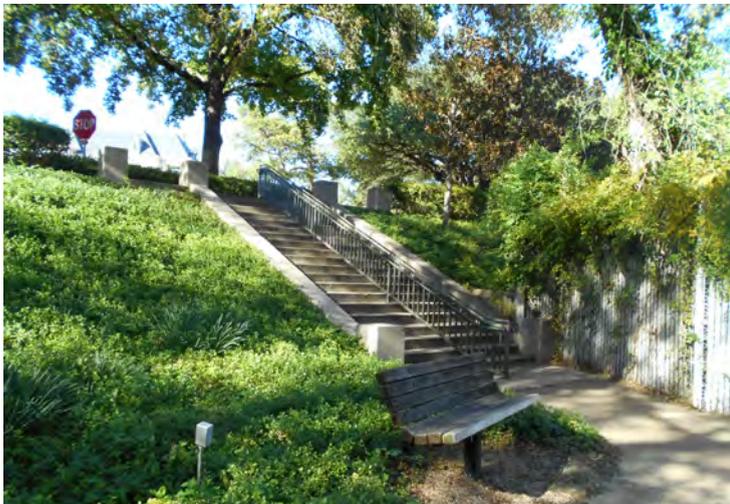
Exhibit 93: Stairway #9

Leading to the Davis Park playground from the intersection of Drexel Drive and Lexington Avenue, this stairway is similar in vintage, style, and construction to Stairways #6, #7, and #8. It shares the same handrail design, though it has a common rail in the middle of the wider stairs rather than on either side. Constructed of concrete, it does not match the stone masonry appearance of other nearby staircases. The handrail substantively complies with current code, except for the missing extensions at the top and bottom of the stairway. The near term recommendation is to leave this stairway as-is, pending the design and construction of the proposed Lexington Avenue Esplanade.

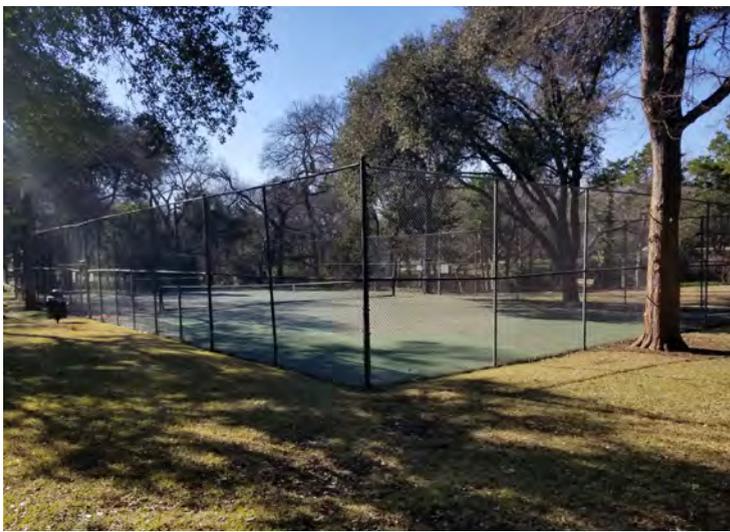
Exhibit 96: Tennis Court #7

This tennis court is located near Pedestrian Bridge #6. The improvements include construction of a post tension concrete slab, new fencing, windscreens, backboard, bench and accessibility improvements. The court lighting needs to be restored or replaced. Landscape enhancements are recommended to soften the utilitarian appearance of the fence.

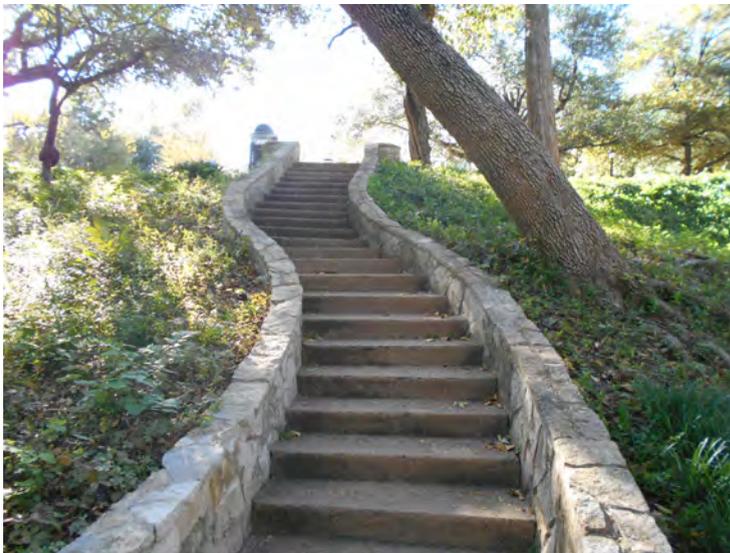
Exhibit 97: Stairway #10

would not suffice for current codes for accessibility or safety standards. The upper stairway appears structurally sound, with treads and risers constructed of concrete, while the lower is somewhat deteriorated. The upper steps are attractive and in good repair, and should be maintained and preserved in their current condition. The lower stairway should be considered in conjunction with the proposed reconstruction of Pedestrian Bridge #6 and the reconstructed elevated trail along the western edge of the creek.

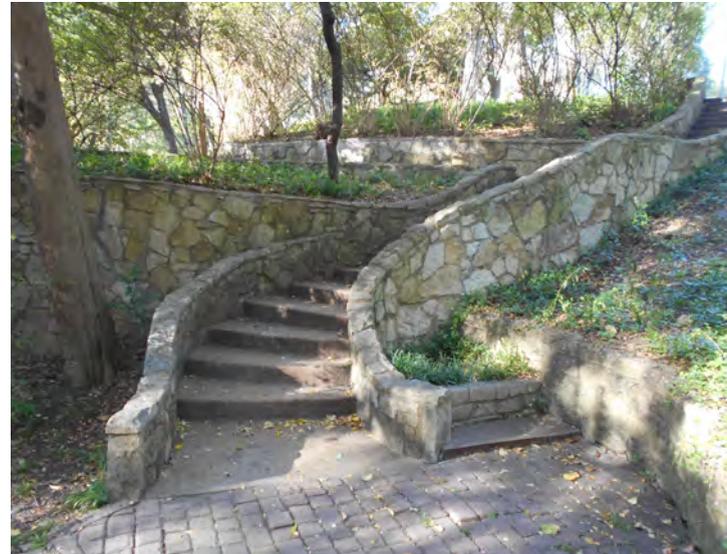
Exhibit 98: Stairway #11

This meandering stairway has a whimsical quality winding down the hillside along Drexel Drive. It has gently undulating limestone walls on either side blending with retaining walls along the hillside. These walls would not suffice for current codes for accessibility or safety standards. The stairway appears structurally sound with treads and risers constructed of concrete. Overall, the steps are attractive and the stone veneer is in generally good repair, though some cracking is evident. This stairway should be maintained and preserved in its current condition. The lower stairway should be considered in conjunction with the proposed reconstruction of Pedestrian Bridge #6 and the reconstructed elevated trail along the western edge of the creek.
