*Highland Park*  
TEXAS

# HACKBERRY CREEK CORRIDOR

Conceptual Design & Development Report

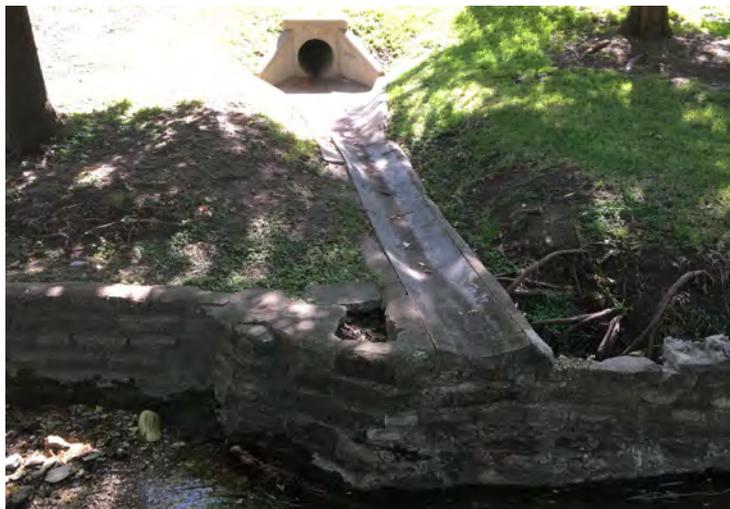
Exhibit 14 Before: Existing culvert and headwall near Princeton Avenue and St. Johns Drive

The consulting engineer's assessment indicates that the interior of the structure exhibits signs of significant deterioration. The structure is potentially in need of replacement. A feasibility study should be conducted to formulate a design response guiding the reconstruction of the culverts, headwall, and street crossing.

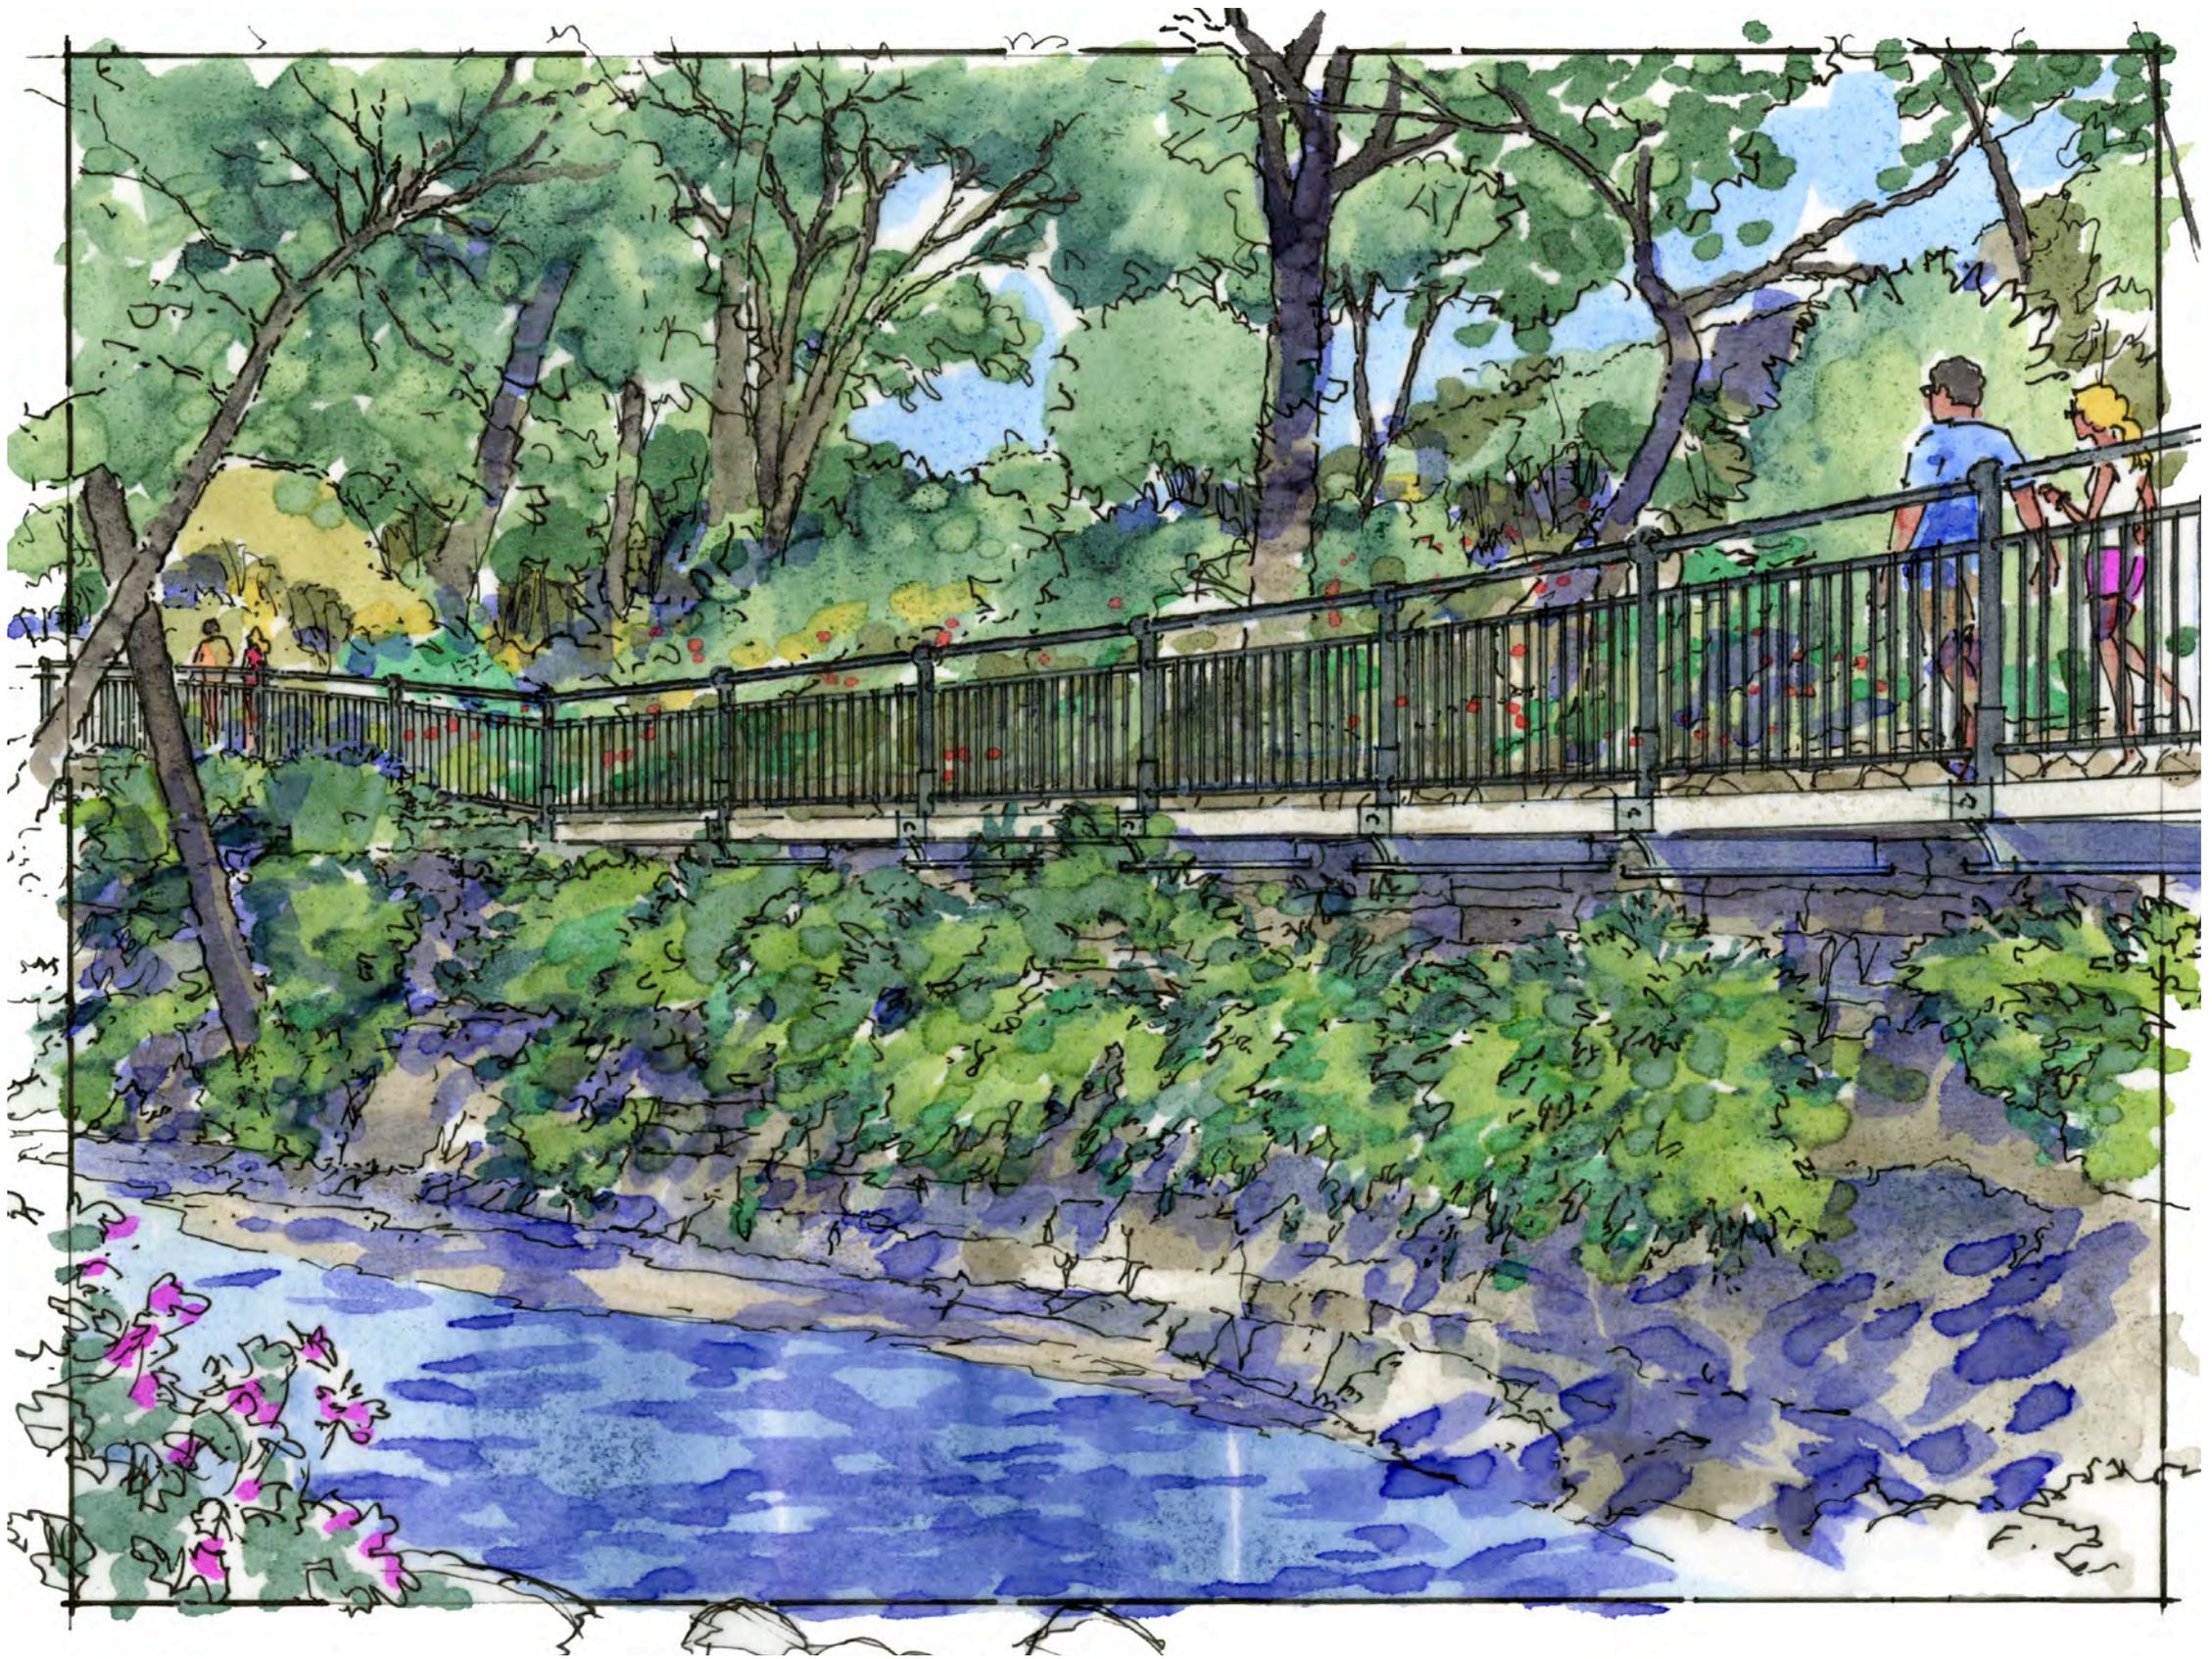
Exhibit 16 After: Perspective view of the walkway over the Creek in Davis Park

In exhibit 15 on page 14, the raised pedestrian walkway between Pedestrian Bridge #6 and Pedestrian Bridge #7 indicates erosion of the bedrock undermining the existing sidewalk. Picturesque holly fern has established a colony in the crevices creating a unique landscape encounter along the walkway. As a measure to preserve the historic (and scenic) alignment of the sidewalk, the rendering

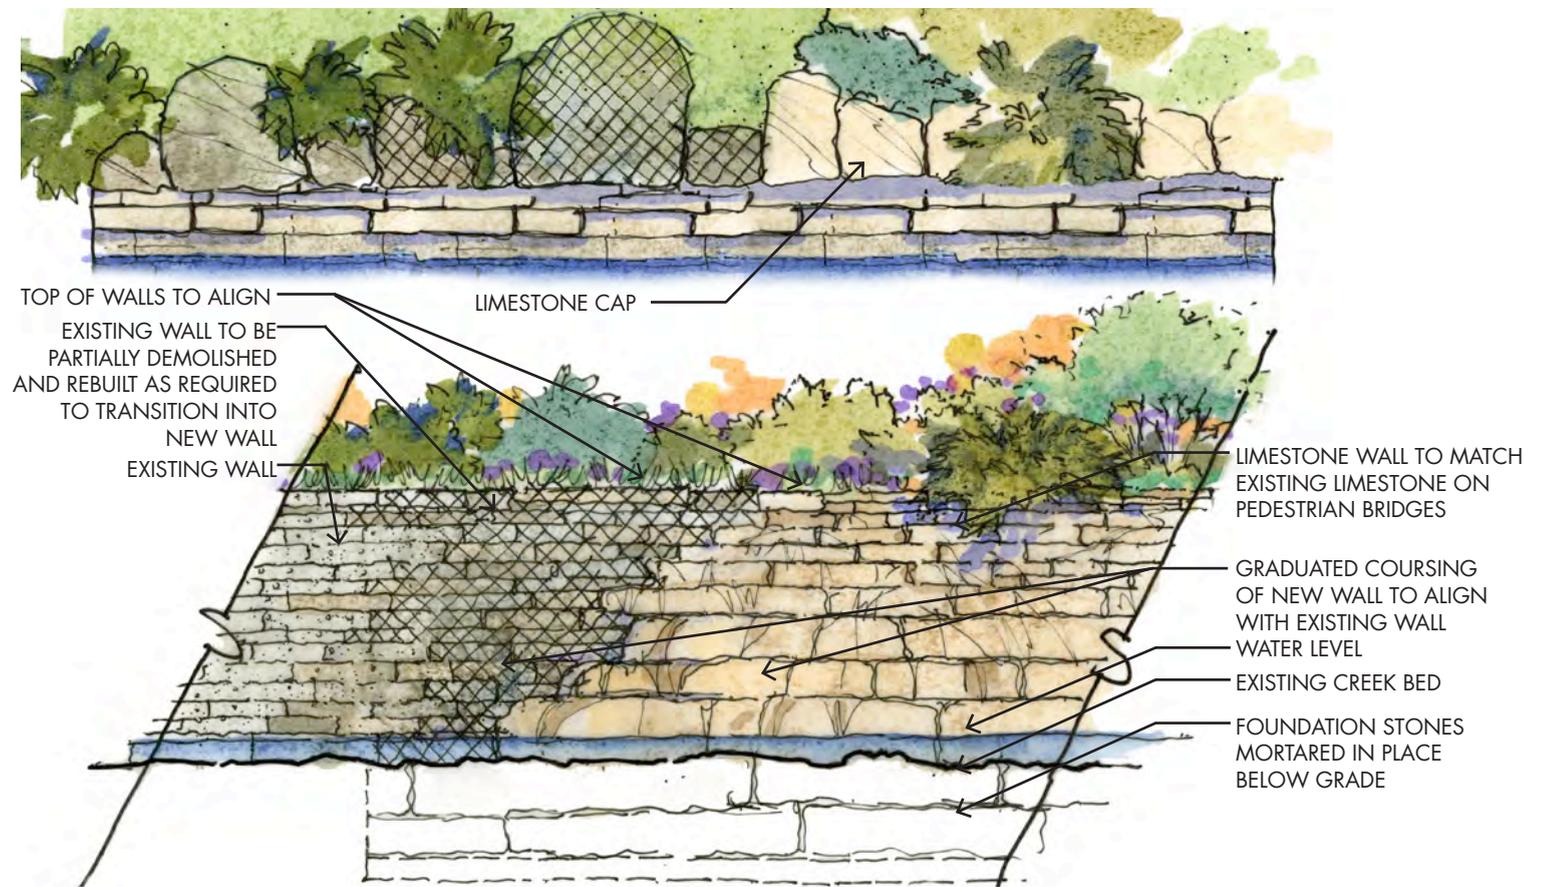
Exhibit 17 Elevation and plan of limestone veneered wall

Some of the channel walls are failing due to erosion and undermining of their foundations. Specific designs should be commissioned for areas of reconstruction to best respond to the local geology and field conditions. The exhibits on page 16 show two preferred methods for transitioning new and repaired walls back into soft banks and integrating them into existing walls. Exhibit 17 depicts an elevation and plan view of a limestone veneered wall blending into the coursing of an existing masonry creek channel wall. The limestone coursing would match the coursing of the adjacent existing wall and then transition into a graduated pattern with larger “boulder” stones on the bottom of the wall and smaller “builder” stones on the higher courses. All of these stones would be roughly rectangular on the front, top, bottom, and sides. The plan view indicates the monolithic would have a regular front profile and an irregular rear profile transitioning back into the soft bank or landscape terrace. Exhibit 18 shows how the walls will terminate into the soft bank or terrace using larger rectangular boulders transitioning into irregular boulders anchored into the bank, giving the wall the appearance of being built into the native geology. The specific limestone used for these walls and boulders should resemble the native bedrock and limestone used for constructing the historic pedestrian bridges. The consulting engineer has proposed three conceptual methods for the reconstruction of the walls based on field observations. Conceptual applications and details for these walls may be found in the Appendix.

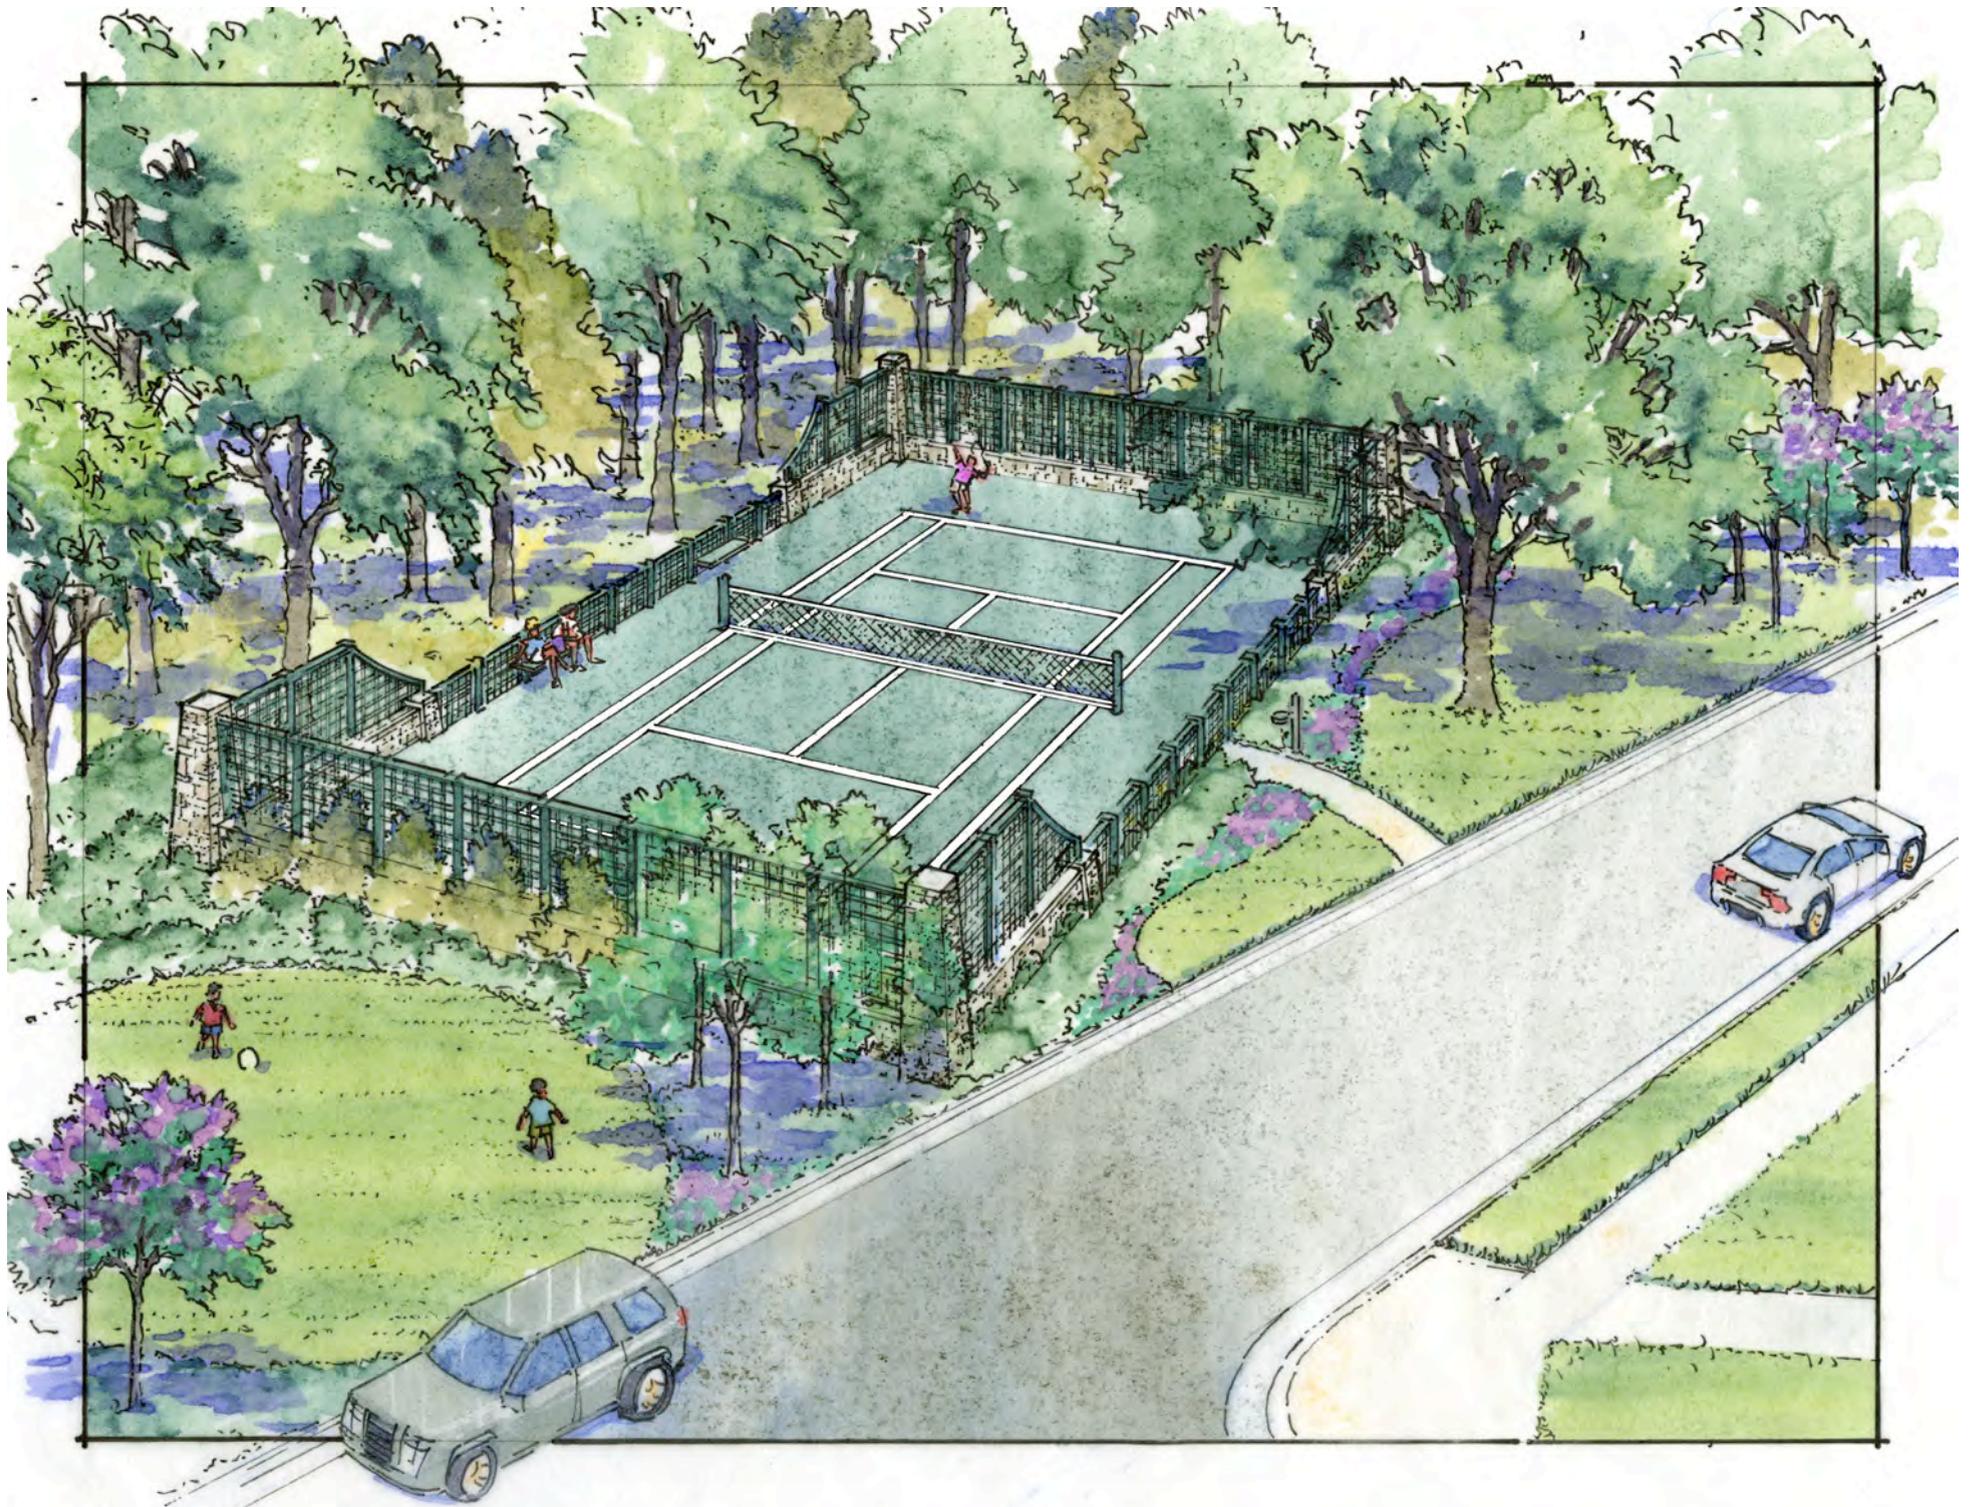
Exhibit 19 After: Perspective view of Tennis Court #2

The perspective sketch in Exhibit 19 on page 18 delineates a design concept intended to gentrify the appearance of the court. The enhancements would remove the chain link fence and windscreen, and replace them with steel lattice and masonry. Windscreen may be incorporated on the court side of the lattice. The height of the fence's middle section would be lowered, giving the court an inviting gardenesque appearance that blends with the architectural form of the corridor. The lowered fence enables public safety patrols to maintain a vigil when the court is not in use. Supplemental landscape around the perimeter of the court would suggest a more harmonious relationship with the surrounding natural landscape. Though this illustration is for Tennis Court #2, the proposed improvements are suitable for Tennis Courts #1 and #7 as well.

This tennis court is planned to be resurfaced in Fiscal Year 2018-2019, in conjunction with the Town's capital improvement plan. Immediate enhancement needs include repairing the existing sidewalk access, and consider adding a drinking fountain.

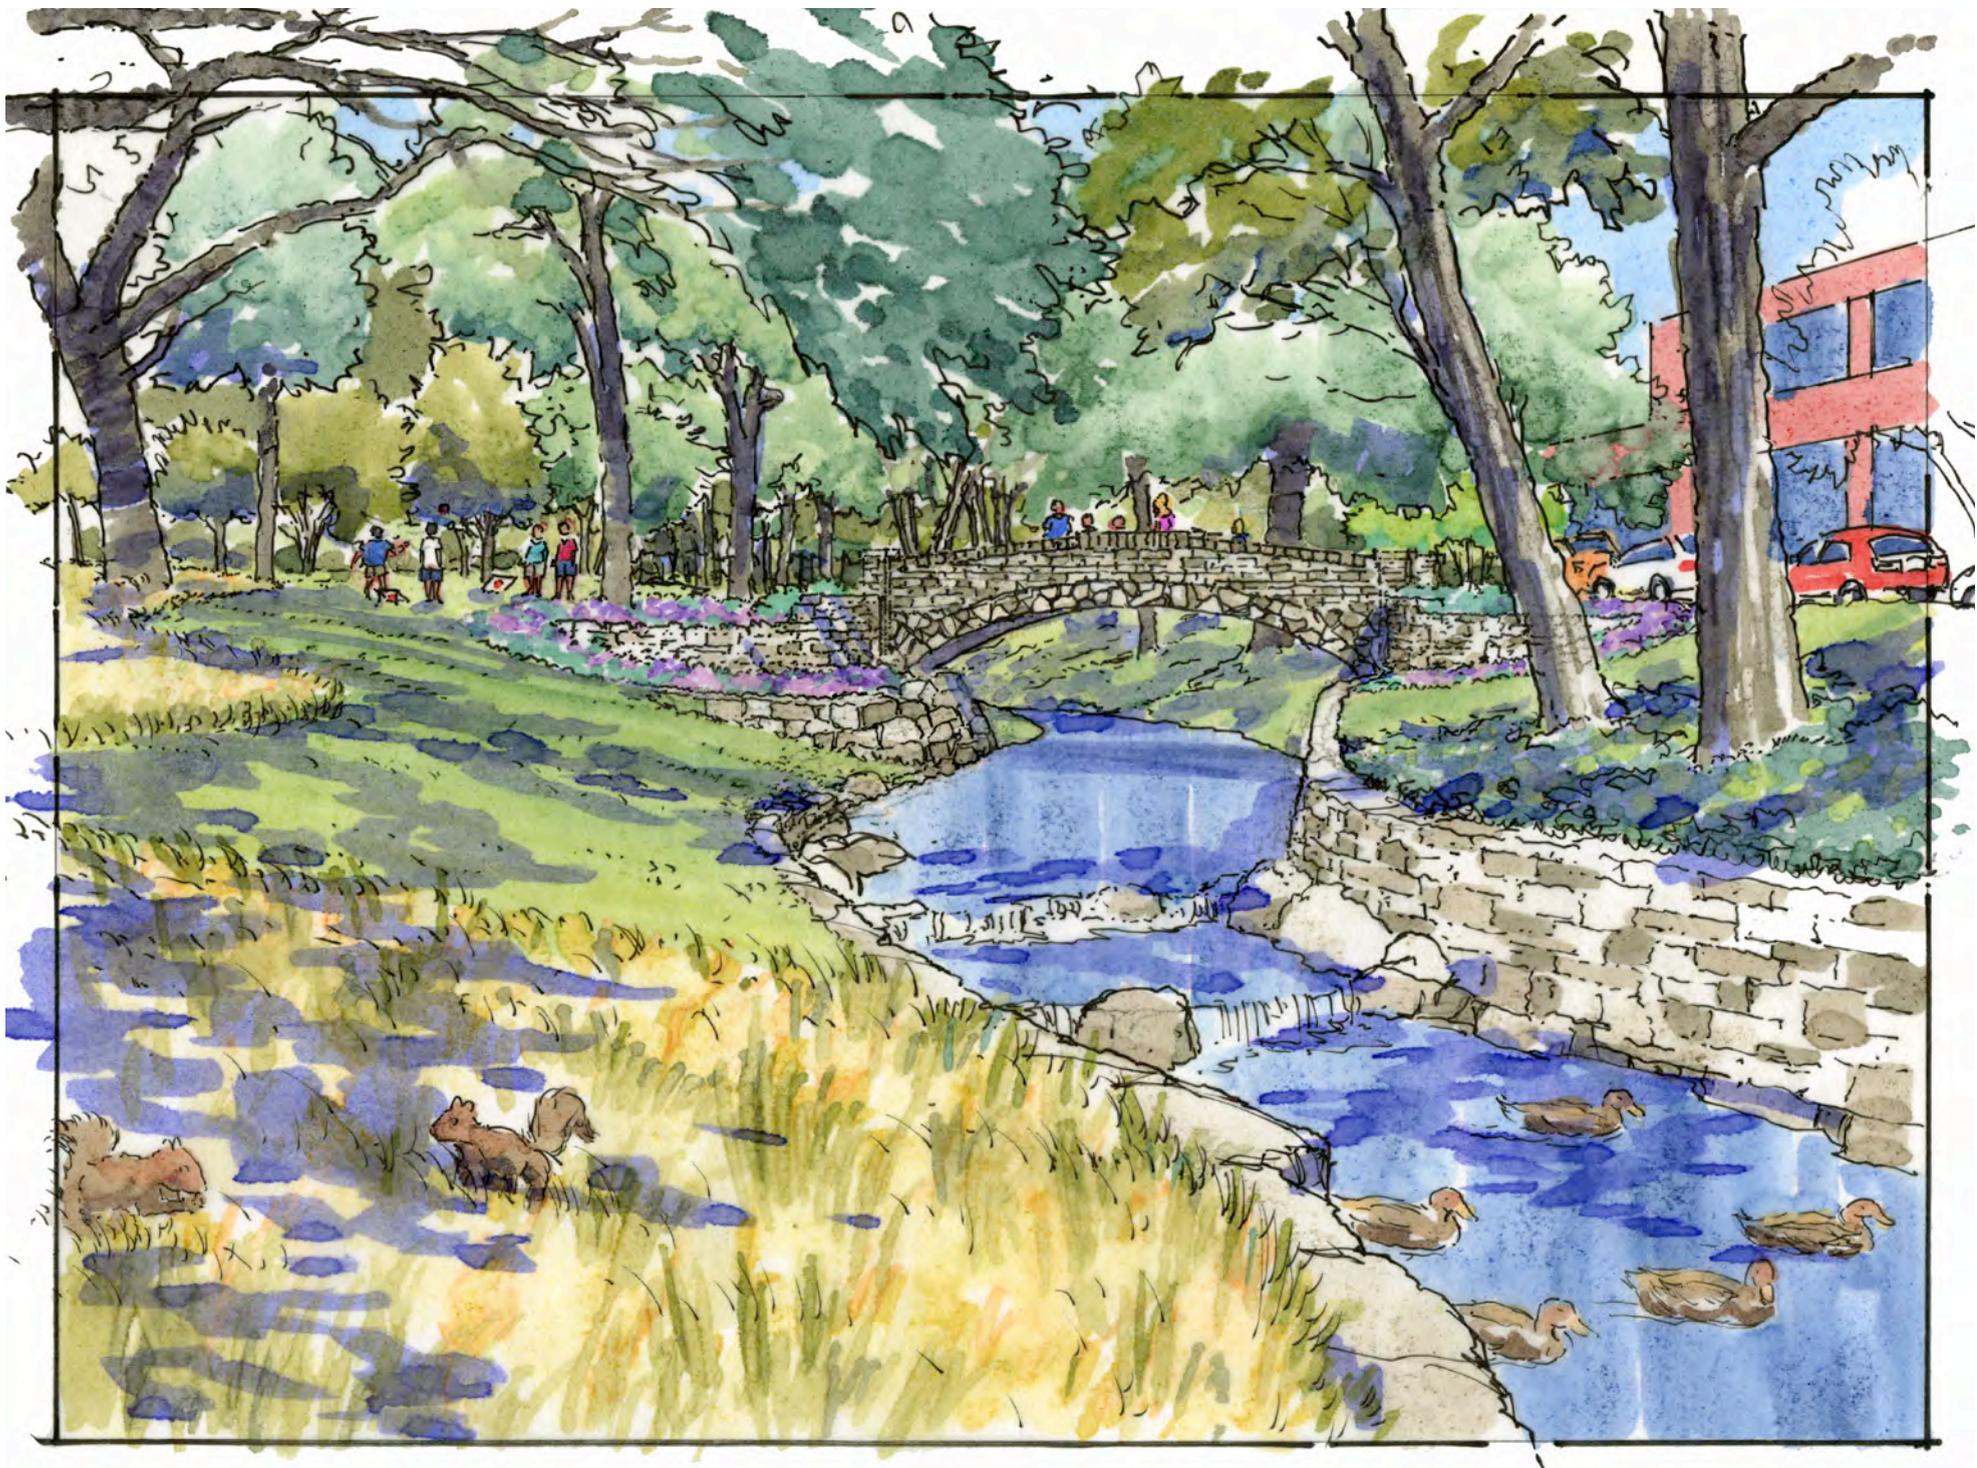
Exhibit 21 After: Perspective view of Pedestrian Bridge #1

Located near John S. Armstrong Elementary School, this structure is in generally good condition. The bridge opening is partially obstructed by fill and a future study should be conducted to analyze the hydraulic benefit of increasing the open area underneath the bridge. Exhibit 21 on page 19 is a sketch of Pedestrian Bridge #1 looking north. The photo of the existing condition, shown in Exhibit 22 (pg. 19), clearly shows landscape on either side of the bridge diminishing its scale and presence over the creek. There is an existing retaining wall on the north side of the bridge, adjacent to the abutment, which constricts flow through the creek. The wall appears to be a remnant of a planter or perhaps armoring a tree no longer there. The suggested enhancements include removing the protruding wall to open the channel and remove the overgrown planting on either side of the bridge. The removed shrubs would be replaced with low growing material cascading over the existing abutment walls.

The western channel wall is shown to be replaced with stepped back slabs of limestone intended to blend with the geology and surrounding landscape. The wall on the east bank would remain in this scenario as the flow of the creek would be unimpeded with the removal of the protruding retaining wall on the north side of the bridge.

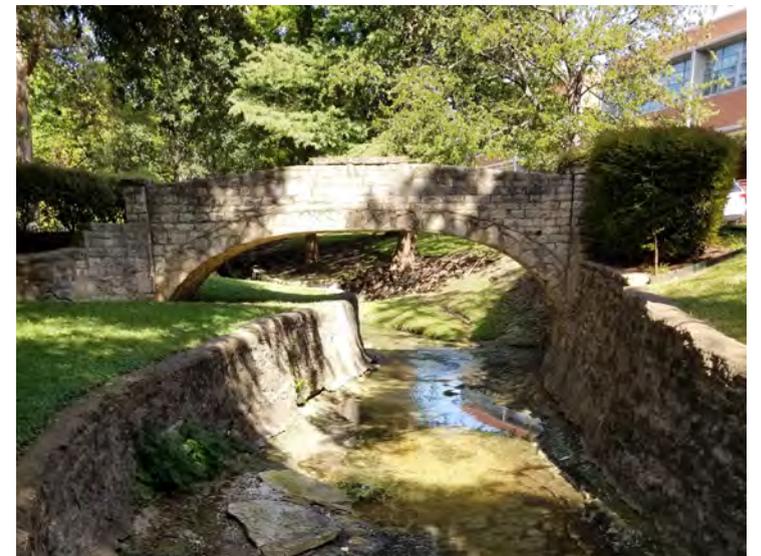
Exhibit 74: Pedestrian Bridge #1

Located near the upstream extent of the Hackberry Creek Corridor by John S. Armstrong Elementary School, this structure is a single span masonry arch pedestrian bridge crossing over Hackberry Creek. The channel bottom

through the area consists of limestone. The deck and superstructure exhibit some minor problems including localized areas of missing or loose mortar, but are generally in good condition. The substructure shows minor deterioration and is in satisfactory condition. The bridge opening is partially obstructed by fill. A future study could be conducted to analyze the hydraulic benefit of increasing the open area underneath the bridge.

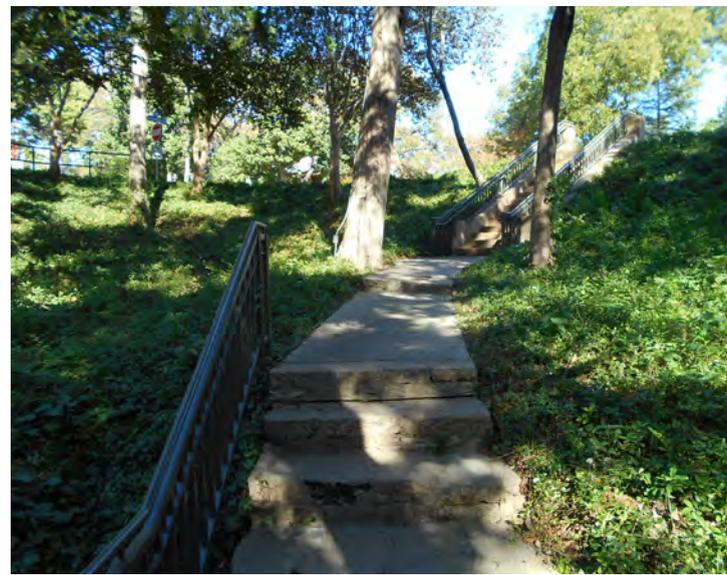
Exhibit 89: Stairway #7

Located on the eastern edge of Davis Park adjacent to St Johns Drive, this stairway and a shorter flight of three steps a short distance down the path lead to Pedestrian Bridge #4 and the Town Swimming Pool. Constructed of concrete similarly to Stairway #8 on the northern edge of Davis Park, this stairway has an elegant handrail that would comply with current codes. The design would be an appropriate prototype for any future railing enhancements in the area. Constructed of concrete, it does not match the stone masonry appearance of other nearby staircases. The handrail substantively complies with current code, except for the missing extensions at the top and bottom of the stairway. The near-term recommendation is to leave the upper stairway as-is. Redesign of this stairway should be considered in conjunction with that of Stairways #8 and #9 in the future. The lower staircase should be reconstructed to blend architecturally with other limestone elements in the park.

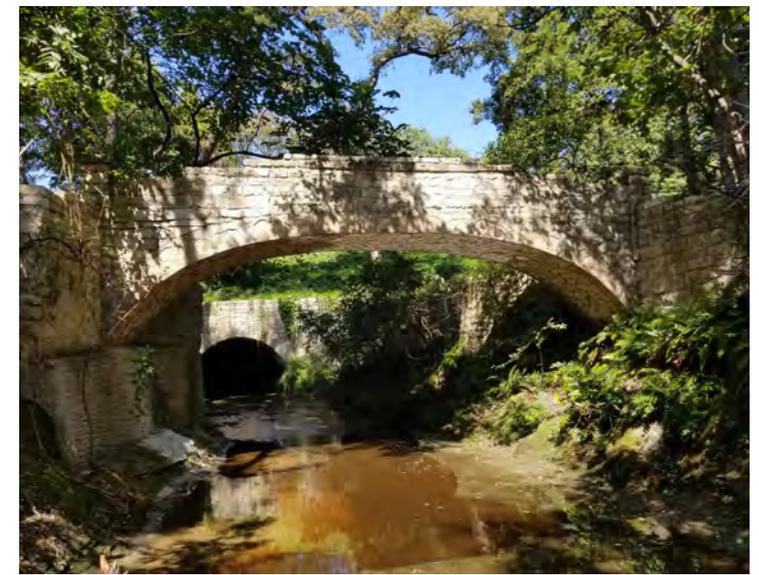
Exhibit 90: Pedestrian Bridge #4

This masonry arch bridge is found at the northern end of Davis Park just downstream of Lexington Avenue. The superstructure is in satisfactory condition. The substructure is in good condition. Previous repairs were made to the bridge abutments by placing a layer of concrete to prevent further deterioration of the masonry stones. In order to camouflage the repairs, the concrete has been textured to mimic the appearance of limestone.

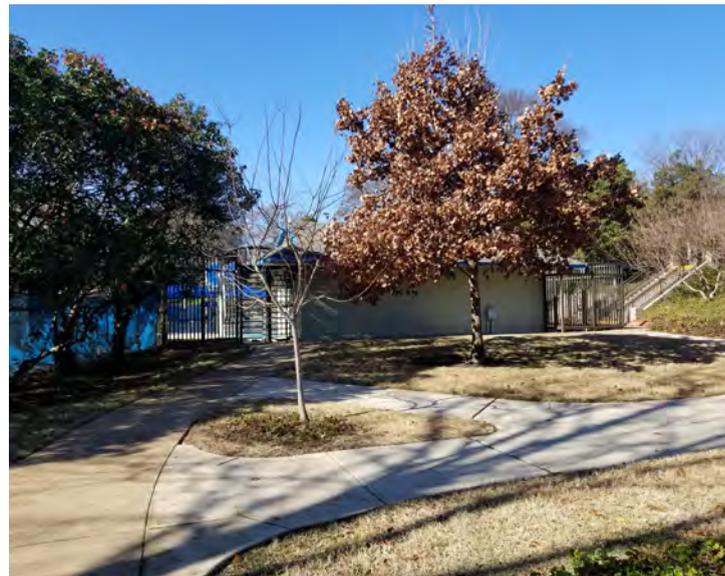
Exhibit 94: Town Swimming Pool

The Town Swimming Pool has served the Town's residents since its most recent construction in the 1950's. The design of the pool and support buildings is inwardly focused, and the fencing and turnstiles confine pool users, and separate them from the surrounding park, open space, and playground. Though utilitarian, the support buildings (concession, etc.) seem out of sync with the surrounding architectural character of the creek corridor and the parks. The current service access within Davis Park should be improved to include paving for emergency access as well as pedestrian convenience. Currently, the pool is operated only during the warm season, and for special events. The design team recommends a study to examine year-round programming opportunities for residents, upgrades and enhancements for accessibility and service, and

improvements to the fencing and support buildings. The addition of architecturally appropriate shade structures, as well as expansion and interface of the fenced pool area with surrounding park and corridor, are much needed improvements for consideration. Remodeling the exterior of the existing buildings with an architectural style complimentary to the area would also be desirable. The Lexington Avenue Esplanade project is one suggested action to address this issue (please see page 36).

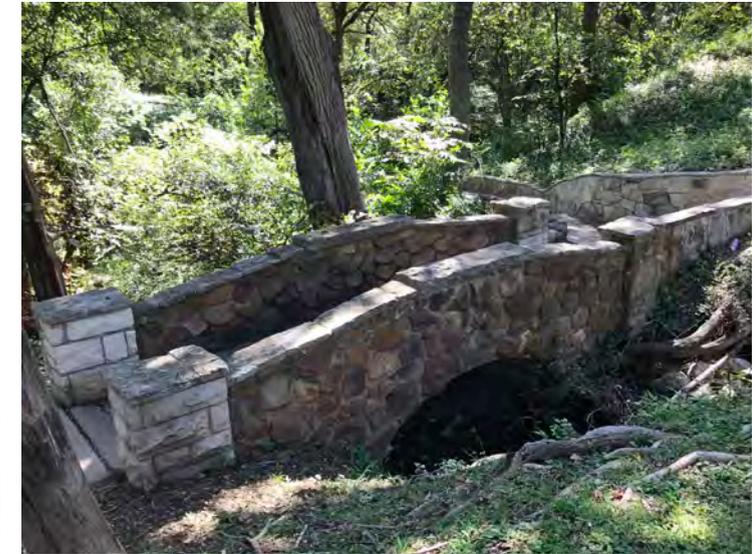
Exhibit 95: Pedestrian Bridge #6

This bridge is found in Davis Park and crosses over a drainage swale. It is a single span concrete arch bridge with stone facing. The concrete deck and approaches exhibit cracking, severe in parts. Additionally, the deck has a minor spall. The mortar of the bridge facing exhibits cracking and is starting to separate from the stones at some locations. Several stones have minor cracking. The underside of the bridge has honeycombing. The concrete footers show signs of concrete deterioration which include exposed aggregate. Multiple voids show at the interface between the arch and stone facing. An electric conduit runs from the bridge face and crosses the swale near the water surface. It appears that this conduit was previously buried, but became exposed due to erosion.

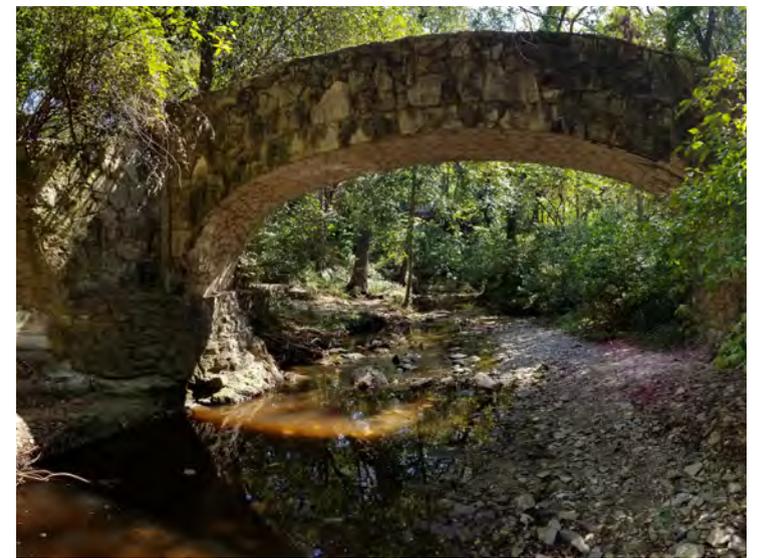
Exhibit 99: Pedestrian Bridge #7

This masonry arch bridge in Davis Park crosses Hackberry Creek south of the tennis court near Alice Circle. The superstructure is in satisfactory condition. The bridge face and underside of the arch exhibits minor stone cracking and missing stones. The substructure is in fair condition. Portions of the abutment have cracks and a section of wing wall is detached and collapsed. The bridge has numerous areas where root growth caused cracking to the substructure elements.

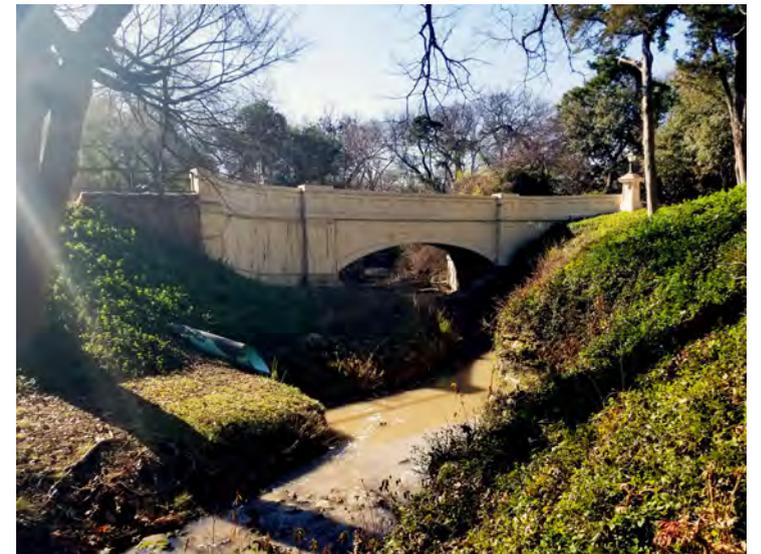
Exhibit 100: Armstrong Avenue

The Armstrong Avenue Bridge is found at the southern end of Davis Park and forms the downstream limit of the Hackberry Creek Corridor. It is a concrete arch bridge

that carries two lanes of vehicular traffic and sidewalks over Hackberry Creek. The deck, superstructure, and substructure are all in satisfactory condition. The hydraulic study shows that the Armstrong Avenue Bridge experiences overtopping due to the backwater effects from Turtle Creek.

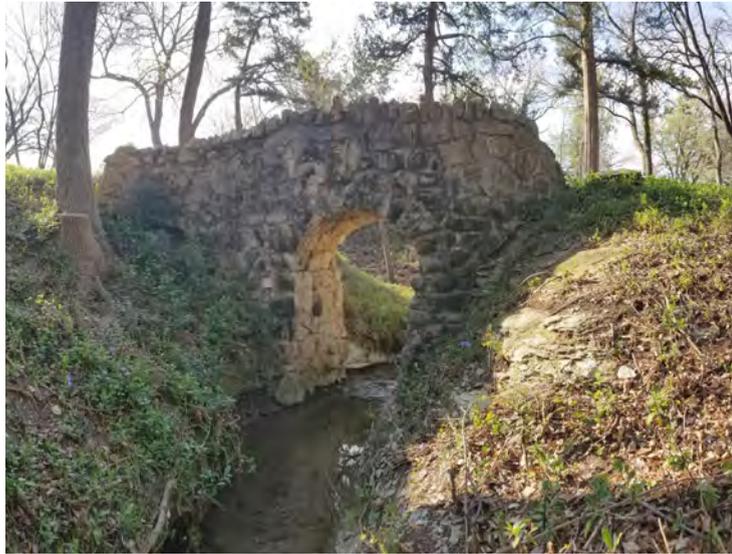
Exhibit 101: Pedestrian Bridge #8

This pedestrian bridge crosses over a small tributary of Hackberry Creek, bound by Alice Circle to the north and Crescent Avenue to the south. The wearing surface of the bridge consists of pavers, which are in good condition; however, the masonry arch is in poor condition. Loose, missing and cracked stones show. Sections of the arch are cracked or are missing mortar. The channel bottom under the bridge consists of limestone, and is in stable condition. No scour was observed. The banks in the proximity of the bridge are well-vegetated and show little sign of erosion.

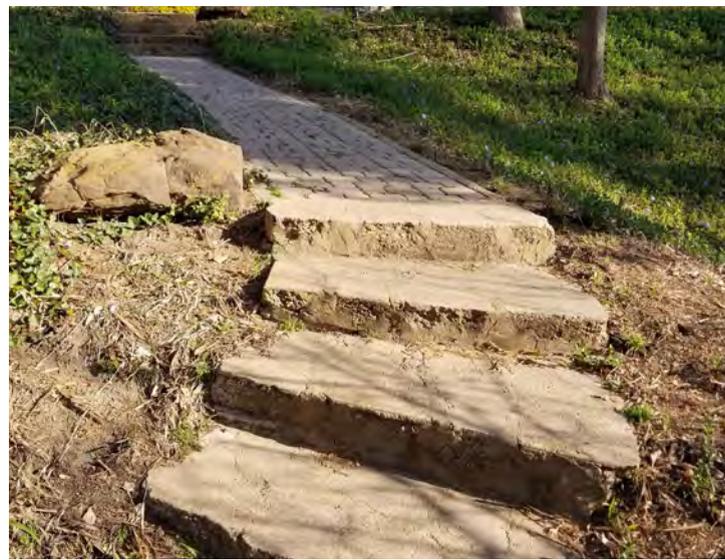
Exhibit 102: Stairway #12

Considered as one stairway for the purpose of this evaluation, the two small stairways along Alice Circle and Crescent Avenue lead to Pedestrian Bridge #8. The stairs are constructed of limestone and are in somewhat good condition. Little cracking seems evident, though some settling has occurred, creating uneven side slopes and riser heights on both staircases. The rustic appearance is appropriate and harmonious with the appearance of the bridge. These stairways should be maintained and preserved as-is, though the concrete pavers should be removed and replaced with flagstone paving. Any alterations should be considered holistically with the bridge.

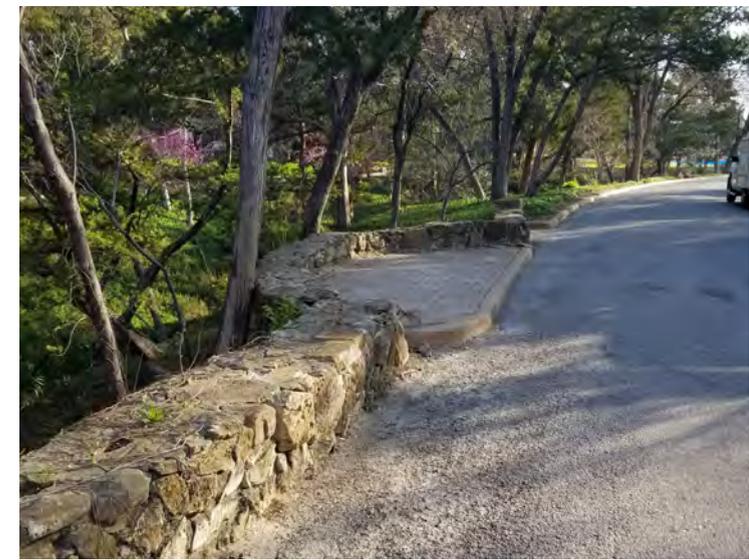
Exhibit 103: Crescent Avenue Overlook

This overlook on the roadside of Crescent Avenue has a wonderful whimsical and romantic quality overlooking the drainage area below. The low wall provides views and casual seating but does not appear to comply with current safety standards. If the overlook is significantly altered, it will likely require a guardrail compliant with current codes due to adjacent topography. The concrete pavers should be removed and replaced with flagstone paving. Such an alteration should be consistent with the belvederes proposed at Beverly Drive and Miramar Avenue (see Vision Projects, pages 32 and 34). A bench may also be added to provide comfortable seating.
